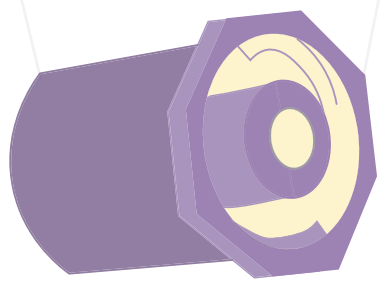
Residual build-up
in the connector
